Subject: Service Bulletin - Ultra LT Fifth Wheel Damage Caused by Improper Coupling

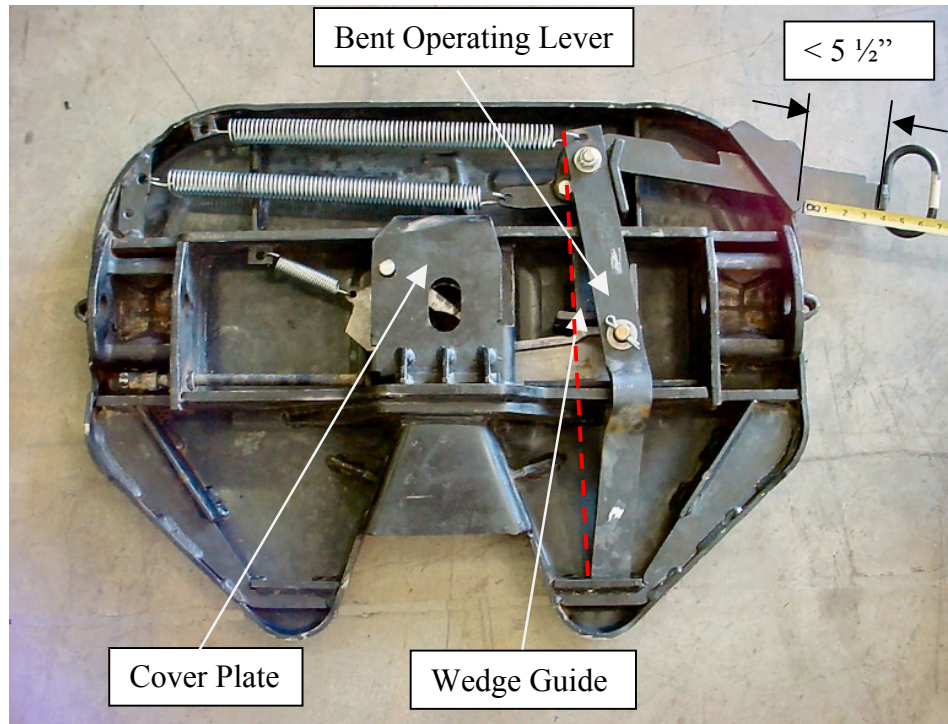
Bent Operating Lever – Pull Handle Dimension < 5 1/2”
Figure 1

1) Perform a thorough visual inspection of the fifth wheel, including underneath, looking for bent or damaged components. Pay particular attention to the operating lever (Figures 1 & 2), the rotating jaw and cover plate (Figures 3, 4, & 5), and the wedge guide (Figure 6). If any components are bent or damaged replace the fifth wheel.

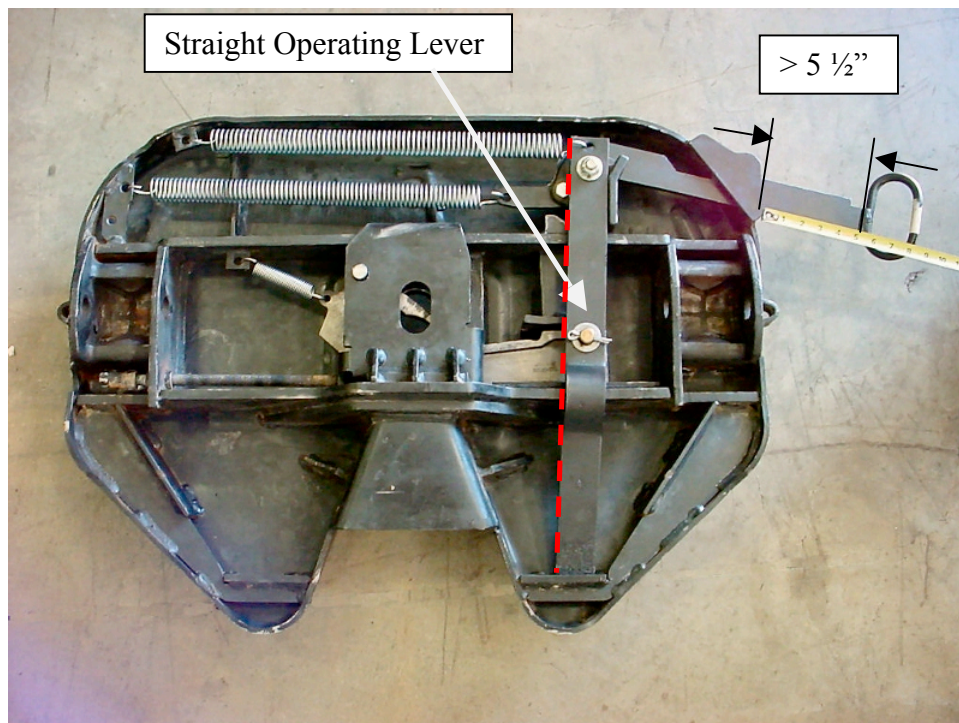
Undamaged Operating Lever – Pull Handle Dimension > 5 1/2”
Figure 2

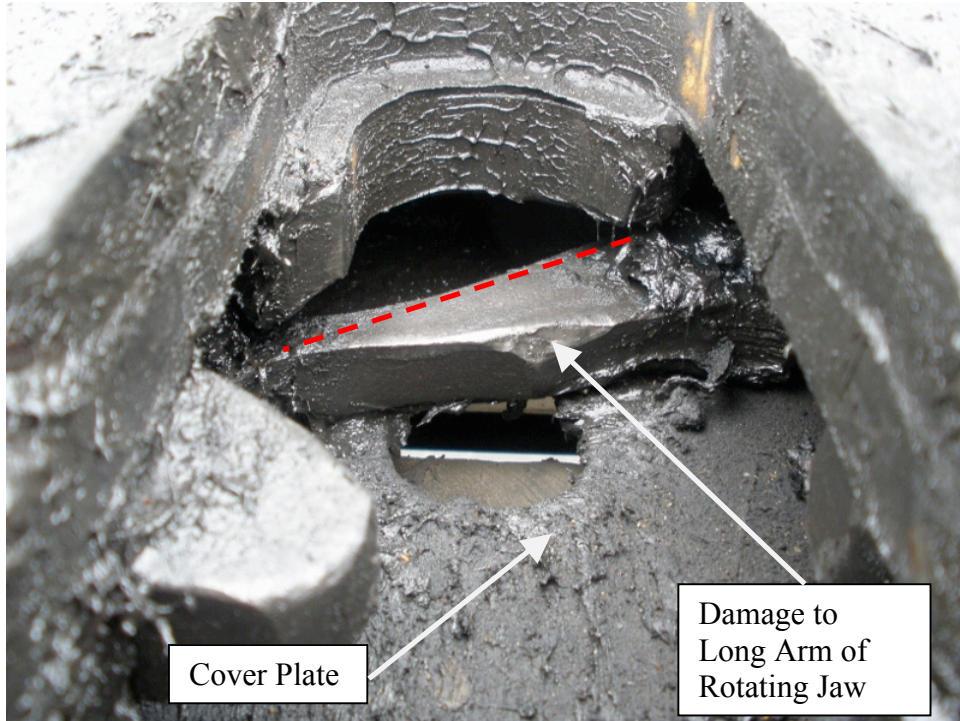
Damage to Rotating Jaw Caused By High Coupling, Resulting in a Bent Cover Plate
Figure 3

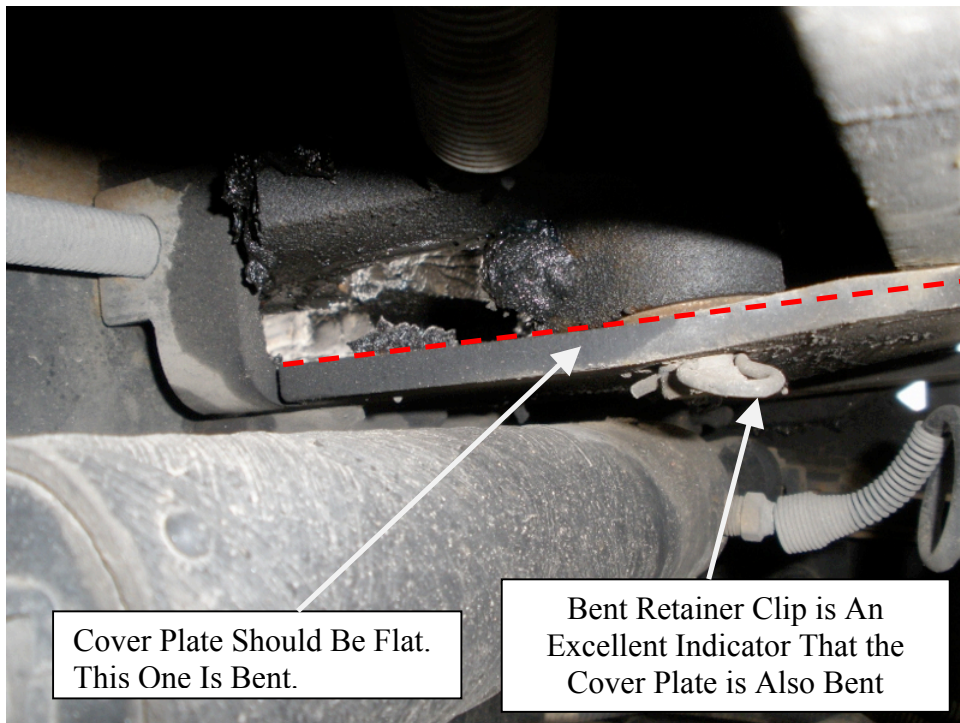
Bent Cover Plate
Figure 4

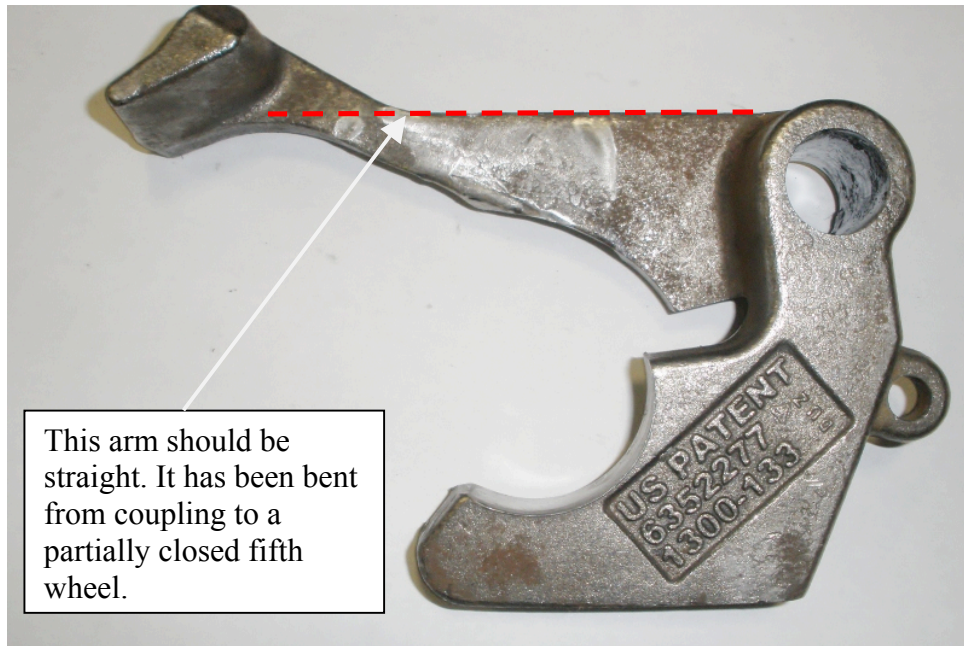
Damaged Rotating Jaw Caused By Improper Coupling
Figure 5

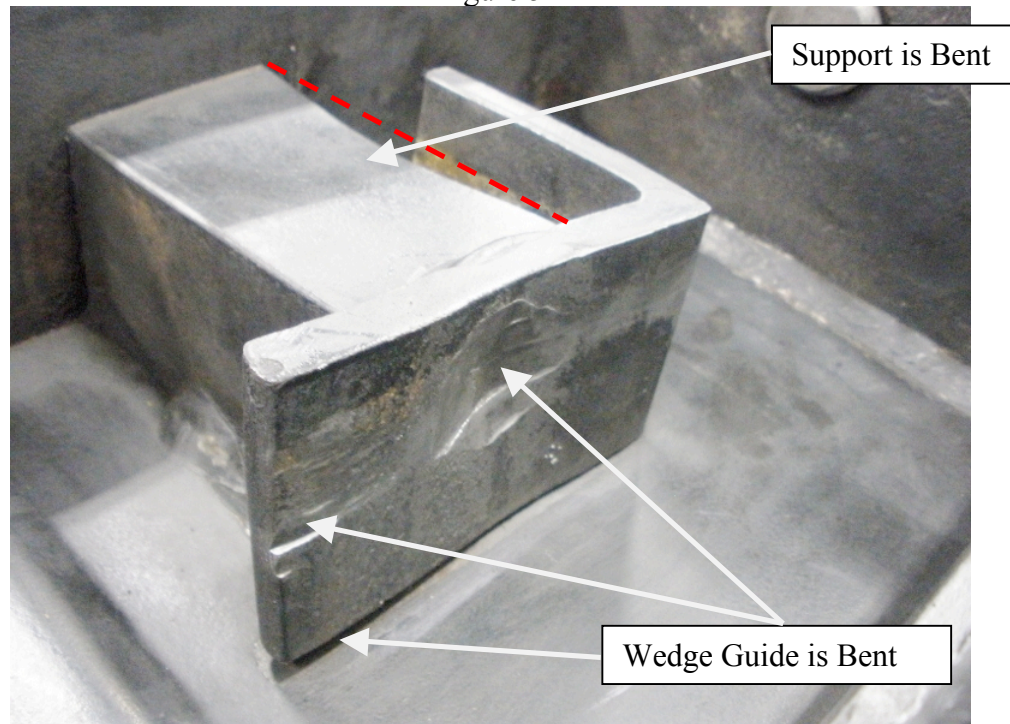
Wedge Guide Damage
Figure 6
