LST™ Fifth Wheel Operation

This technical bulletin is intended to provide more information on the operation and troubleshooting of Fontaine's 7000 and 7000CC series LST™ fifth wheels. Fontaine's LST system uses two electronic sensors to determine if the kingpin is correctly positioned in the lock and relays that information to the in-cab coupling display. This technology improves driver safety and helps identify proper/improper coupling. Also, it provides an additional safety check to supplement the driver's visual inspection and pull test. The in-cab display unit illuminates **green upon successful coupling (locked)** and **red to warn the driver that the fifth wheel has not yet been successfully coupled (unlocked)**. The LST system displays a variety of lights for a range of durations to notify the driver of various issues. These light sequences are described in the next section.

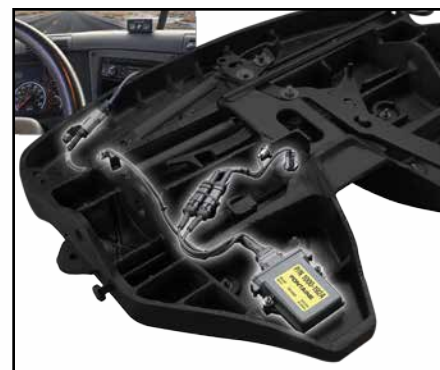
Figure 1: LST Light Sequences

Coupled	Uncoupled	Light Status	Duration	Description
None	None	Off	Continuous	No power to system (within the first 10 minutes of starting the tractor)
Green	Red	Steady on	10 seconds	System start up
Green	None	Steady on	Continuous	Properly coupled
None	Red	Steady on	Continuous	King pin and/or wedge not detected
None	Red	Slow blink*	Continuous	Wedge detected, kingpin not in proper position, not ready to couple.

**The slow steady blink by the unlocked display is reporting the wedge is detected without a king pin and is intended to warn the driver that the fifth wheel is closed before coupling. If this state is reported with a trailer attached verify that the king pin on the trailer meets the standard SAE king pin requirements (SAE J700, Feb 93).*

If the wiring is correct and the correct amount of voltage is present, the light sequences in Figure 1 should be observed first with both the locked and unlocked indicators being displayed for 10 seconds during start-up. The sensors are preset at the factory for correct sensing distance and therefore adjustments are not recommended based on flashing error codes. Check all wiring and connections for any damage. If all power, wiring, and connections have been verified and error codes are still present, contact Fontaine customer service at 800-874-9780.

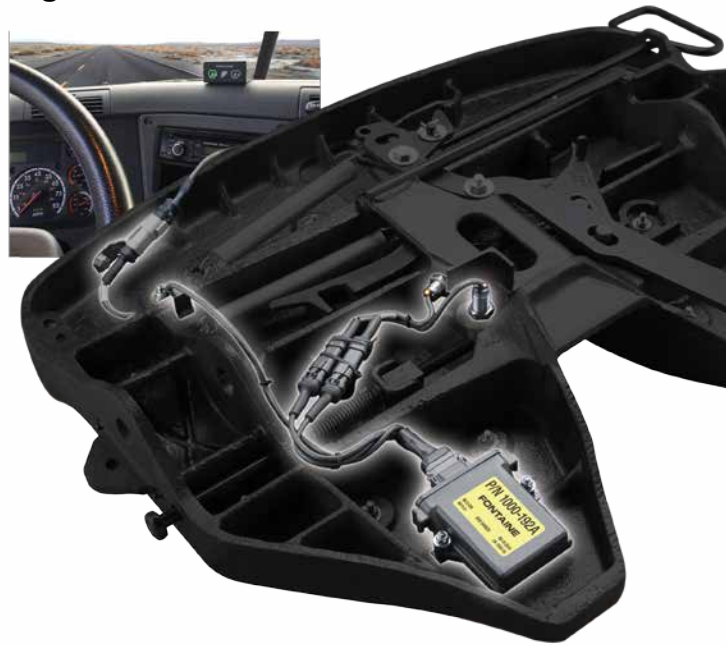
Figure 2: LST Fifth Wheel

The LST system is only available with new fifth wheels and cannot be retrofitted to existing fifth wheels. A display box showing the locked and unlocked lights is also required to be installed in the cab and to be visible to the driver (see Figure 2). The LST system installed by the truck OEM may be integrated into the dash. Refer to the operator's manual or truck manufacturer for the location of these displays.

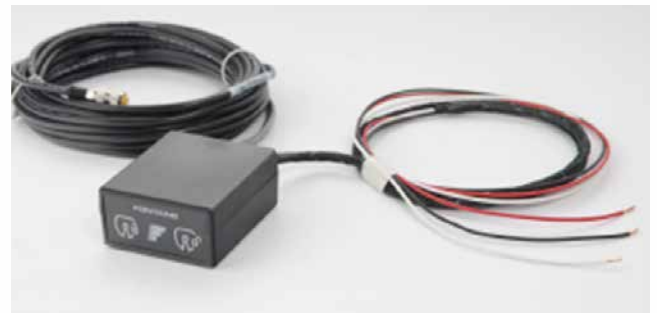
Figure 3: LST display box

Coupling display box with the 31 foot wire (display to fifth wheel connection), a 5.5" long M12 to 4 Pin Deutsch DT coupler cable is also included.

- The red wire should be connected to a 12V battery source
- The black wire should be connected to a ground source
- The white wire is not currently used and should be capped
